Stabilization of a Nearly Collapsed Brick Liner in a Concrete Chimney, and Subsequent Reuse of the Liner

Arun Bhowmik, P.E.

Hamon Custodis, Inc.
Somerville, USA

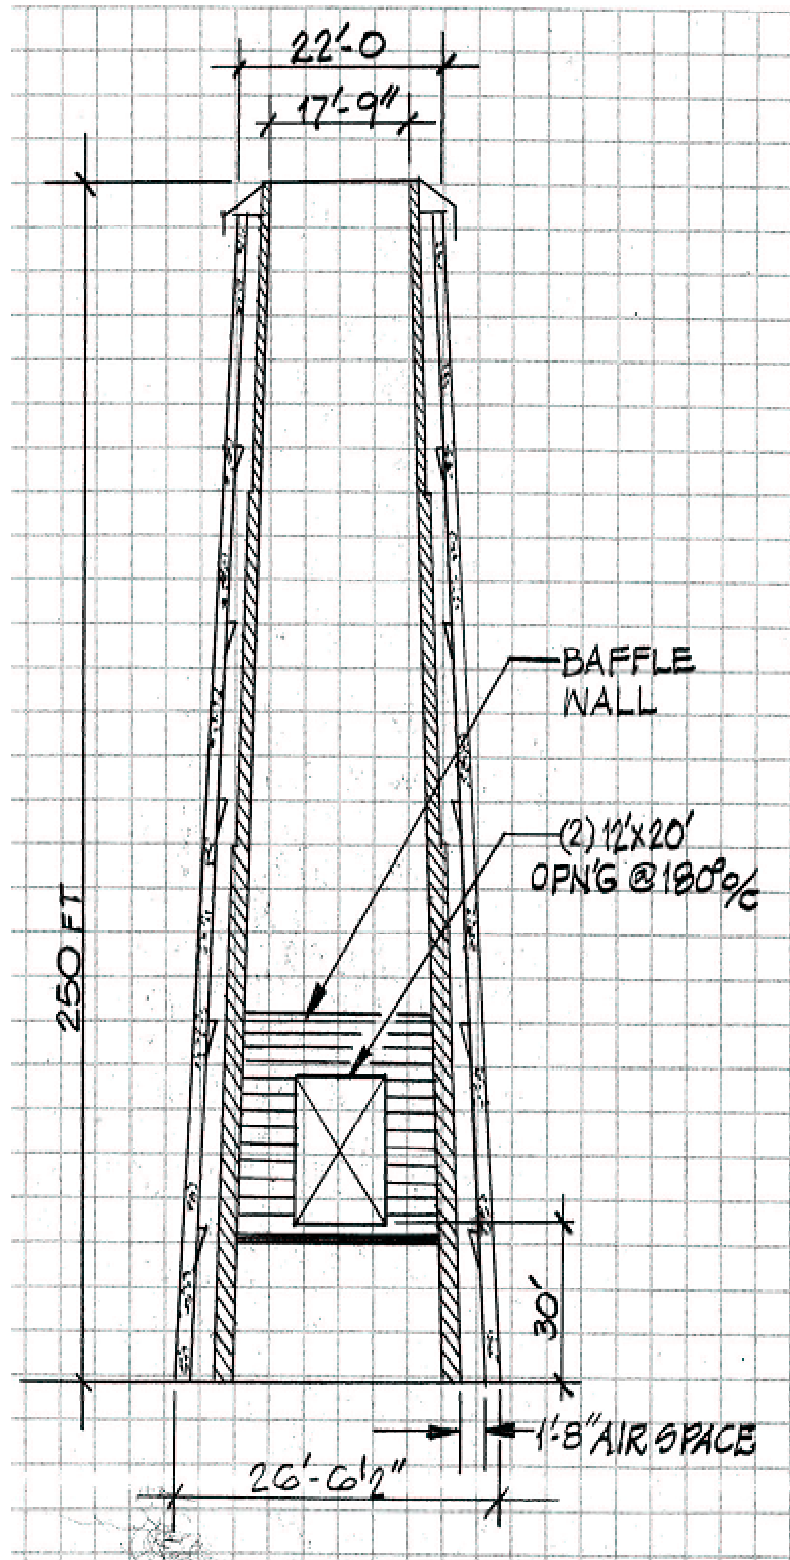
SK-1

This concrete chimney was built in 1962 with corbel supported brick liner. The chimney is 250 feet tall, 22 feet outside diameter at top. In 1975, the liner was removed and a new independent brick liner was installed to suit the new operating conditions. (SK-1)

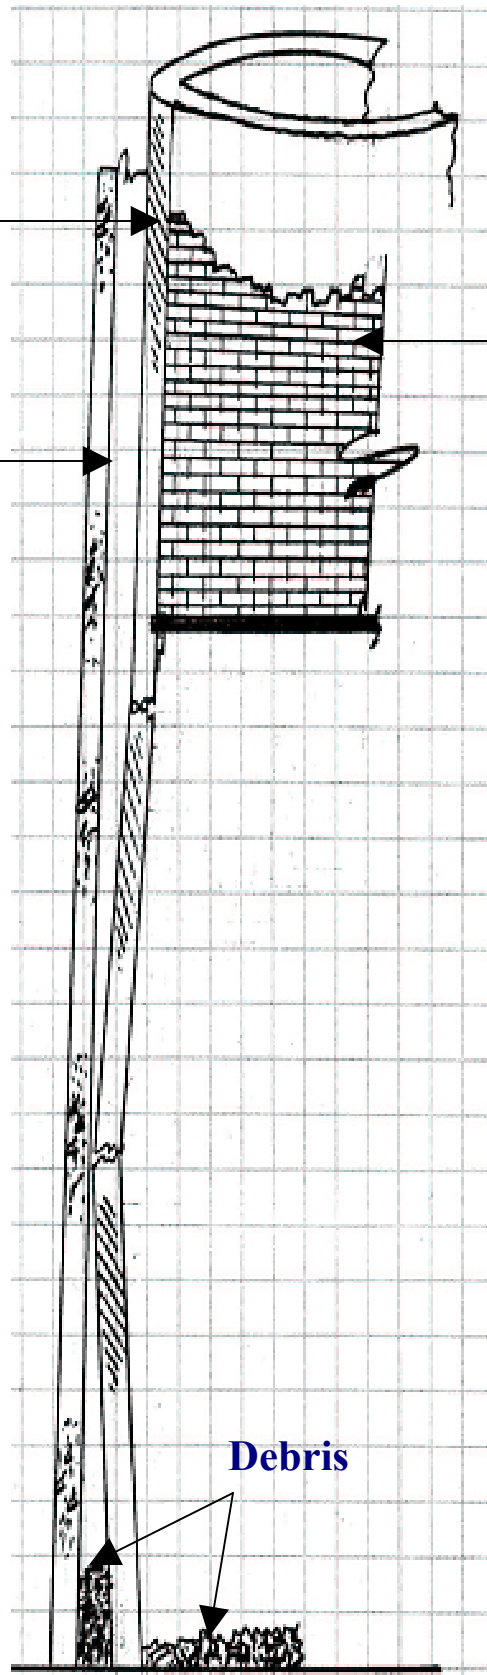
SK-2

The cracks in the liner were very wide, some in excess of 12" in width. However, the cracks looked fairly clean with no debris build up in the cracks indicating sudden failure of the liner. (P-6, SK-2)

Liner

Shell

**Top of
Divider
Wall**

Debris

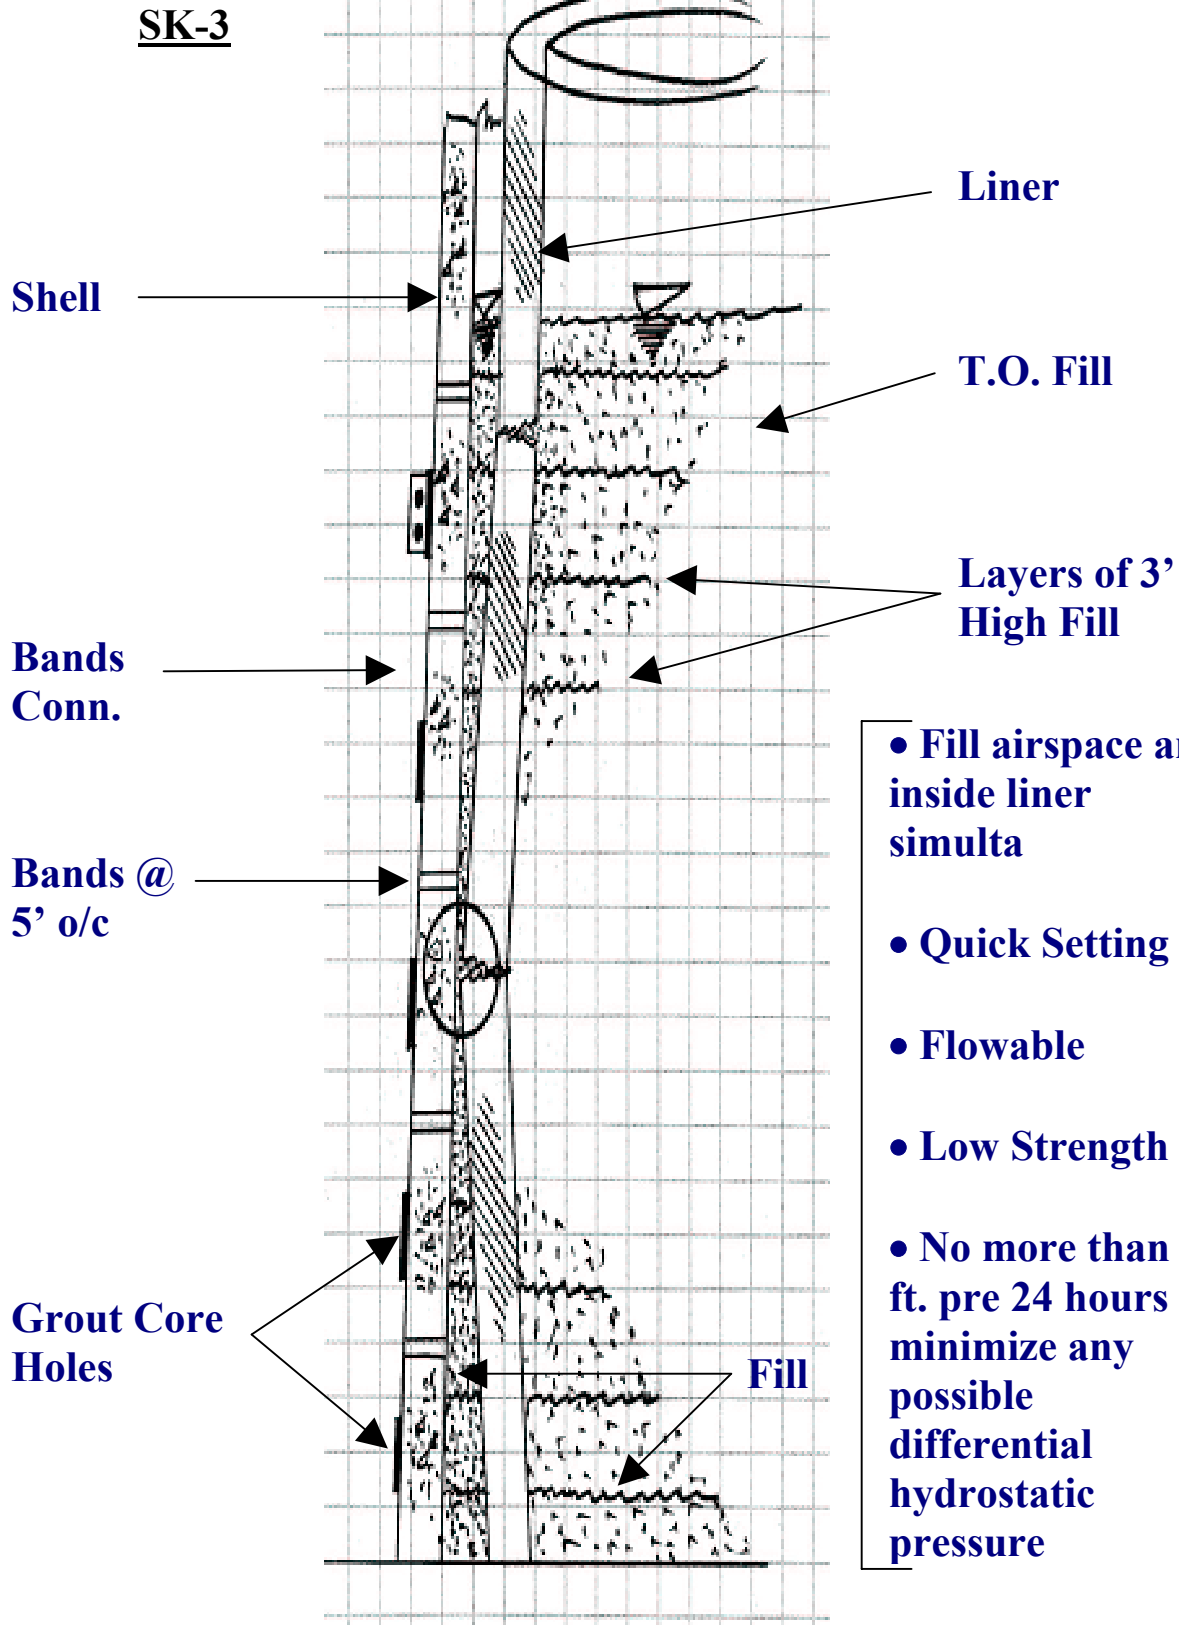
- Fill airspace and inside liner simulta
- Quick Setting
- Flowable
- Low Strength
- No more than 3 ft. pre 24 hours to minimize any possible differential hydrostatic pressure

Based on additional discussions, a decision was made to attempt to stabilize the liner to a point that it can be used for a short period of time until the planned new chimney is built in 2003. Engineering, planning, and fabrication activities started at a frantic pace and round the clock. ([SK-3](#))

Small holes were drilled around the chimney shell to obtain air space measurements and monitor any liner movement. Wide steel bands were designed to be installed on the chimney exterior. 6” diameter holes were cored around the chimney wall for placement of grout. A grout mix with flash was designed that will set within a few hours, and will have low strength which will be desirable during eventual demolition of the chimney. Height of pour will be limited to 3 feet per 24 hours to maintain low hydrostatic pressure. A method was devised to ensure same level of grout in the airspace and inside the liner to minimize differential hydrostatic load on opposite sides of liner wall.

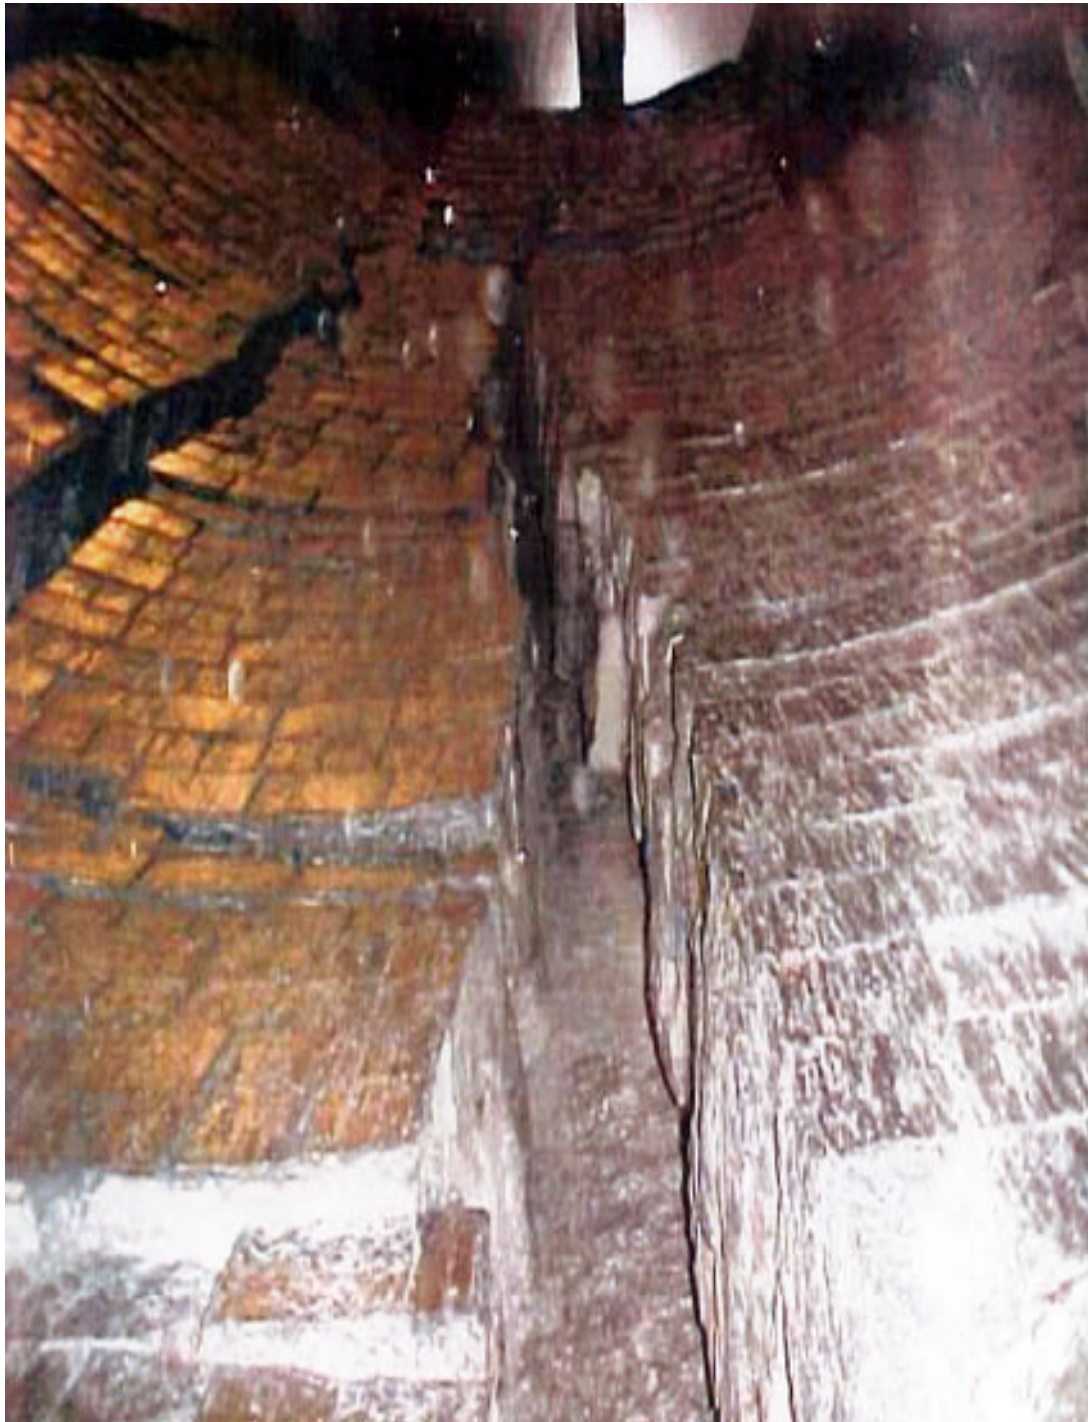
P-6: Cracked Liner Wall

In early March of 2001 during an inspection, it was found that the bottom 30 to 35 feet of the liner wall had severely cracked, the wall segments had broken and bowed out. (P-6, P-6A) The air space at the bottom of the chimney was quite small (1'-8" at base), which prevented the broken liner wall segments from further bow out and total collapse. There was significant amount of debris on the floor inside the liner and in the airspace. (P-7) The top section of the divider baffle wall was broken (P-8) and many bricks were dislodged and fell on the floor.

After careful evaluation of the situation, it was decided that encasement of the bottom 35 feet of the liner in a low strength grout plug will stabilize the liner from further cracking or movement which will prevent a catastrophic chimney failure.
